USAAEFA PROJECT NO. 83 - 21

ARTIFICIAL AND NATURAL ICING TESTS YEH - 60A QUICK FIX HELICOPTER

JUNE 1984

FINAL REPORT

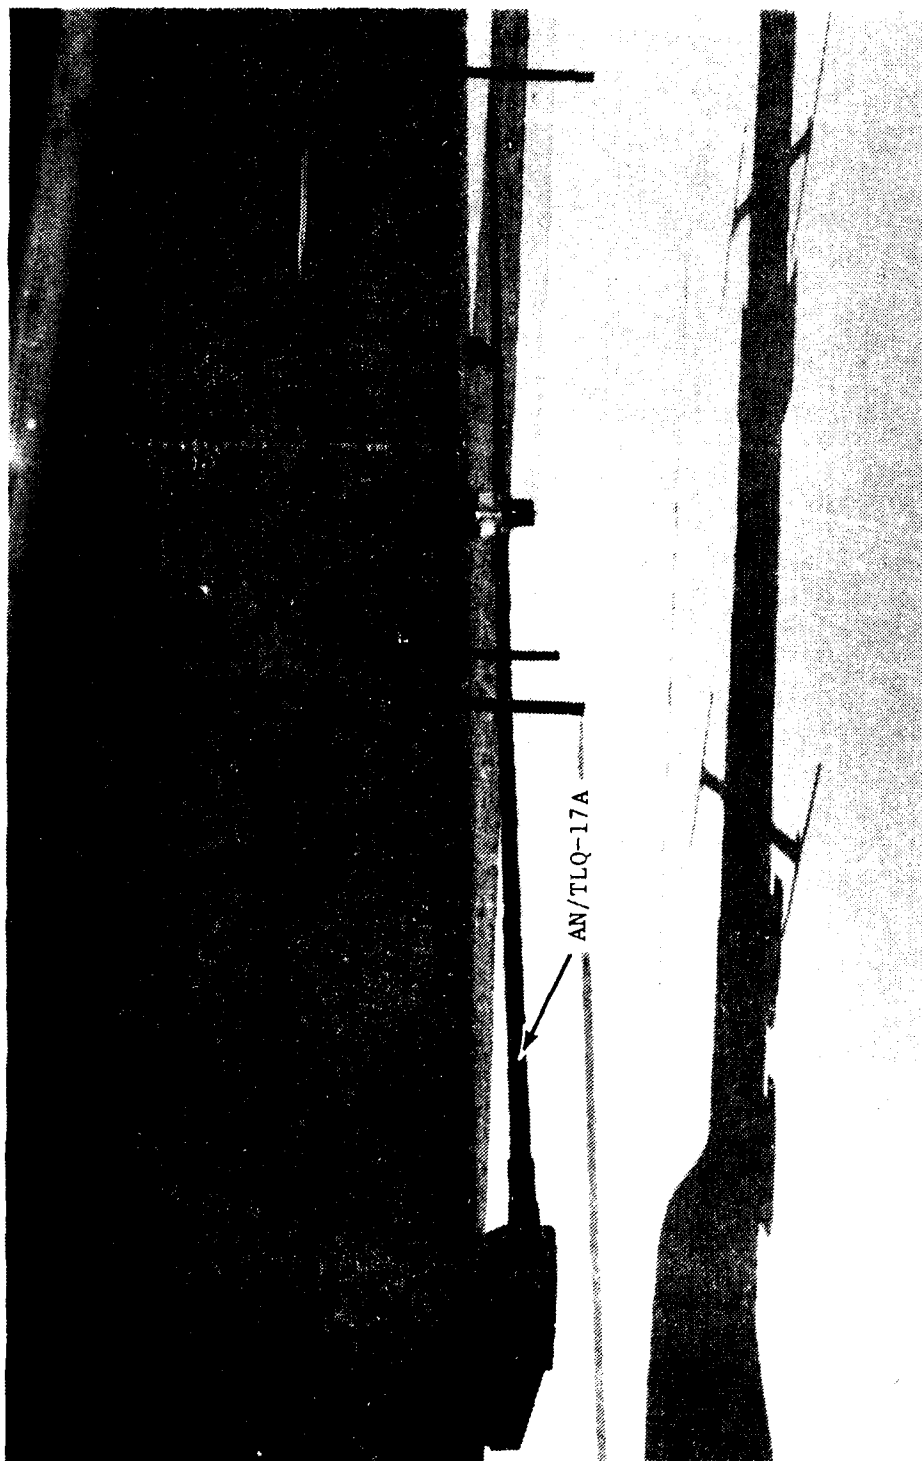
Photo 7. Electronic Countermeasure Antenna - Retracted

5. The ECM antenna is an eight pound 109 inch long monopole antenna mounted on the fuselage just forward of the tailcone assembly (fuselage station (FS) 483) as shown in photos 7 and 8. Constructed of 1/8 inch thick hollow aluminum tubing, its diameter varies incrementally from 3.0 inches at its base to 0.50 inches at the tip. The ECM antenna rotates downward and forward pivoting about the base mounting structure to extend. Power for ECM antenna extension is provided by an electronic actuator controlled by a three-position guarded switch on the center instrument panel (fig. 3). The ECM antenna will automatically retract whenever the copilot's radar altimeter is turned on and the aircraft's absolute altitude becomes less than the value selected on his L (LO SET) indicator. Whenever the ECM antenna is fully retracted, the ANTENNA RETRACTED status advisory light on the caution/advisory panel will go on and remain on. When the antenna is fully extended, a light on the ECM operator's console marked ANTENNA DEPLOYED will go on and remain illuminated until the

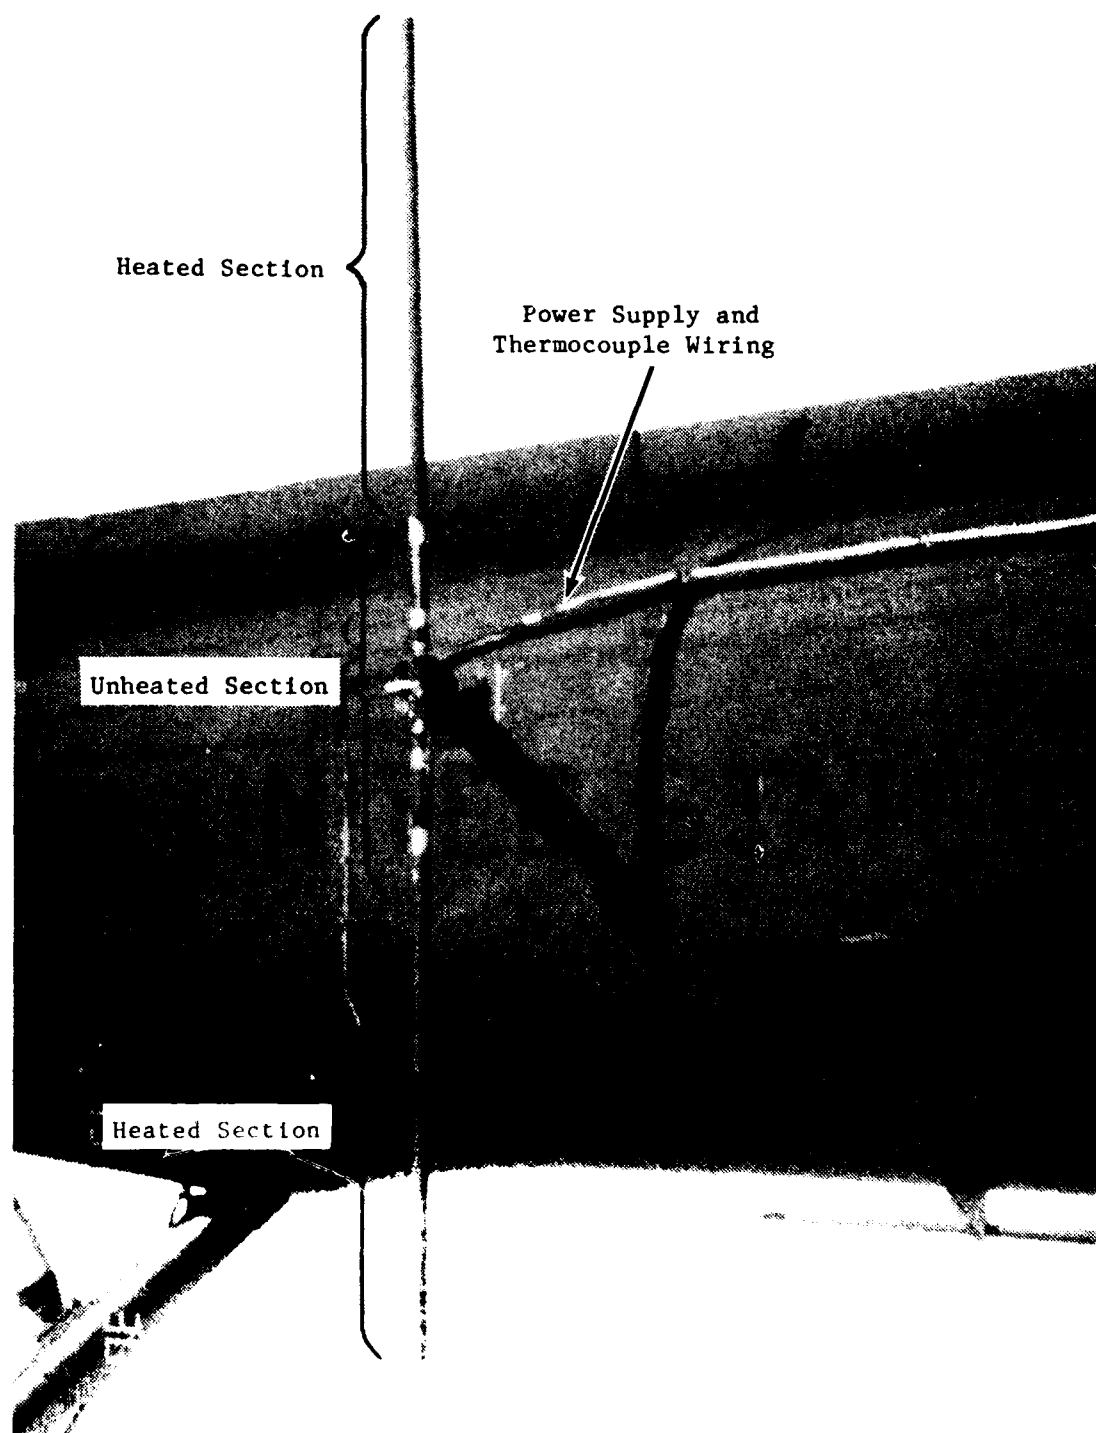
Photo 7. Heated Direction Finding Dipole Antenna #3

16. The ice accretion characteristics of a thermo-electrically anti-iced DF dipole antenna were evaluated at the specific test conditions listed in table 1, appendix F. These characteristics were documented in artificial and natural icing conditions as depicted in figures 1 and 2, respectively. Before starting icing tests, the anti-iced antenna was flown in clear air and antenna surface temperature recorded as a function of airspeed and altitude (fig. 3, app F). The anti-iced DF antenna was mounted in position #3, the aft antenna mounted on the right side of the tail cone (photo 7, app H). All other DF antennas were removed for subsequent icing tests. The antenna's anti-ice protection was provided by 900 watt heater elements bonded inside each antenna element. Heated operation was manually controlled by cabin and cockpit mounted switches. No ice accumulation was noted on the heated portions of the DF antenna elements during flight in either natural or artificial conditions. Ice accretion
